**Flood Control Project Maintenance
Levee Inspections**

Maintenance Issue Types Only, Levee Inspection Report By Mile - Spring 2017

Reclamation District No. 0001 Union Island

Waterway	Bank	Unit Miles	Inspection Start/End	Inspector
Unit No. 01 Old River	Right	1.14	04/12/2017 04/12/2017	Maksim Khashchuk

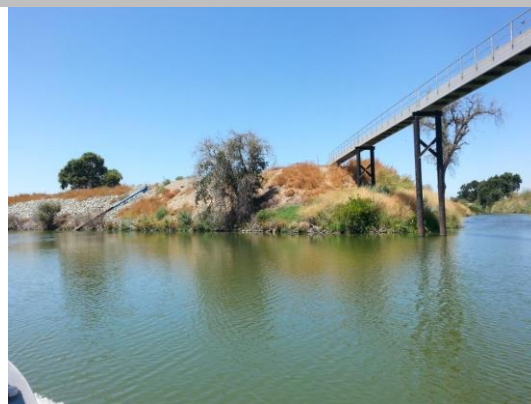
Photo 1 of 3 : SP_2017_RD0001_23_1_20170407_00001.jpg

LM Start	0.00	Rating **	M	Issue No.	1
LM End	0.00	Issue Type +	Ma	Location *	WS
Category	Supplemental		GPS Latitude/Longitude		
			Start	End	
Item	DWR Erosion Survey		37.822306 °	37.822306 °	
			-121.375304 °	-121.375304 °	
DWR ID	DWR_RD0001_01_s_2017_1				
Comment Code					
Inspector Comment					
07/25/2016: No significant change observed. 06/25/2015: No significant change observed. 07/02/2014: No significant change observed. 08/20/2013: No significant change at this site. 08/07/2012: The erosion is at the confluence of Old River and one of its tributary. [2016 Site ID:RD0001U01RM31.4]

Upstream view of the erosion.

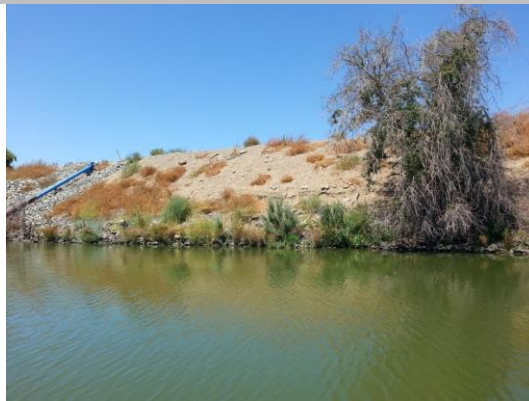
Photo 2 of 3 : SP_2017_RD0001_23_1_20170407_00002.jpg

Close view of the erosion.

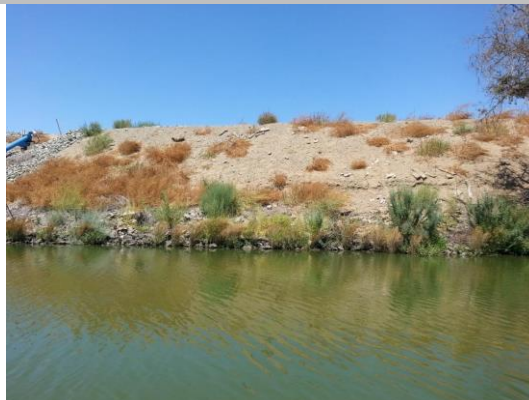
Photo 3 of 3 : SP_2017_RD0001_23_1_20170407_00003.jpg

Front view of the site. Note the large tree on site.

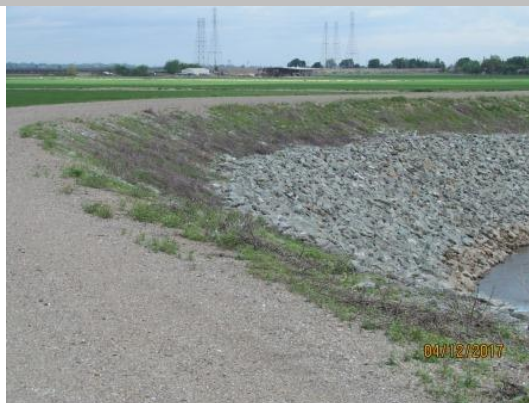
Photo 1 of 1 : SP_2017_RD0001_23_17_20170417_00016.jpg

LM Start	0.01	Rating **	A	Issue No.	17
LM End	1.02	Issue Type +	Ma	Location *	WS
Category	Earthen Levee			GPS Latitude/Longitude	
				Start	End
Item	Vegetation			37.822435 °	37.812796 °
				-121.375722 °	-121.383933 °
DWR ID	DWR_RD0001_01_s_2017_17				
Comment Code					
V1 : Control annual grass and weeds on the levee slopes and easements.					
Inspector Comment					
Acceptable vegetation control.

View of the acceptable vegetation control on the levee slope.

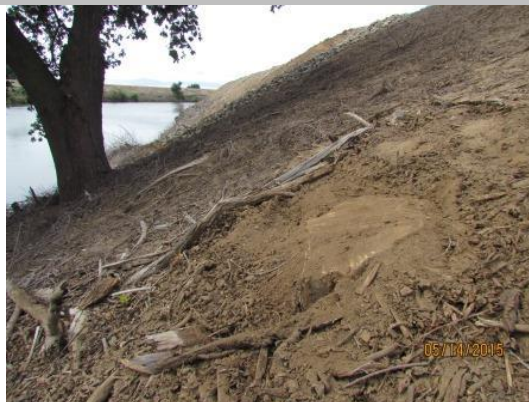
Photo 1 of 1 : SP_2017_RD0001_23_12_20170407_00010.jpg

View of the tree stump on the waterside levee slope.

LM Start	0.17	Rating **	N	Issue No.	12
LM End	0.17	Issue Type +	Ma	Location *	WS
Category	Earthen Levee			GPS Latitude/Longitude	
				Start	End
Item	Trim / Thin Trees			37.821376 °	37.821376 °
				-121.378044 °	-121.378044 °
DWR ID	DWR_RD0001_01_s_2014_12				
Comment Code					
T5 : Tree stumps.					
Inspector Comment					
Remove stump when it becomes rotted to prevent possible seepage path along the roots.

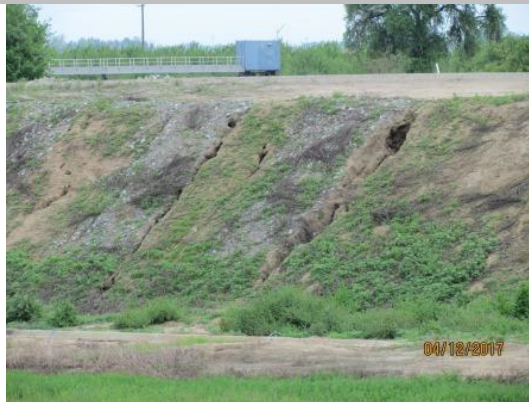
Photo 1 of 1 : SP_2017_RD0001_23_18_20170417_00017.jpg

View of the erosion on the levee slope.

LM Start	0.21	Rating **	M	Issue No.	18
LM End	0.21	Issue Type +	Ma	Location *	LS
Category	Earthen Levee			GPS Latitude/Longitude	
				Start	End
Item	Erosion / Bank Caving			37.820806 °	37.820806 °
				-121.378260 °	-121.378260 °
DWR ID	DWR_RD0001_01_s_2017_18				
Comment Code					
E2 : Schedule repair of erosion site prior to the next inspection.					
Inspector Comment

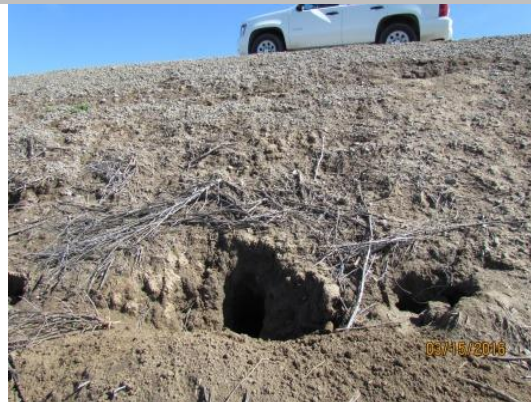
Photo 1 of 1 : SP_2017_RD0001_23_14_20170407_00011.jpg

View of the large rodent hole on the landside levee slope.

LM Start	0.44	Rating **	U	Issue No.	14
LM End	0.44	Issue Type +	Ma	Location *	LS
Category	Earthen Levee			GPS Latitude/Longitude	
				Start	End
Item	Animal Control			37.818898 °	37.818898 °
				-121.380332 °	-121.380332 °
DWR ID	DWR_RD0001_01_s_2016_14				
Comment Code					
A1 : Exterminate rodents and backfill and compact or grout burrows.					
Inspector Comment					
Active rodent den a size of a coyote or fox.

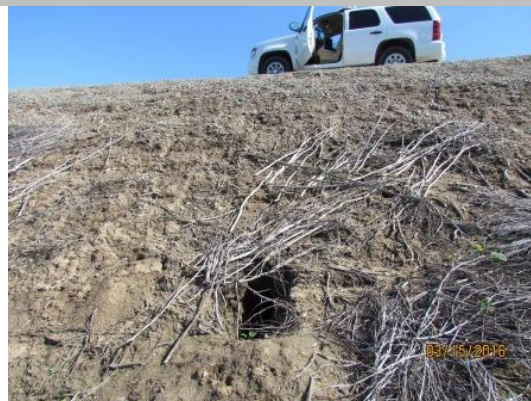
Photo 1 of 1 : SP_2017_RD0001_23_10_20170407_00008.jpg

View of the large rodent hole on the landside levee slope.

LM Start	0.45	Rating **	U	Issue No.	10
LM End	0.45	Issue Type +	Ma	Location *	LS
Category	Earthen Levee			GPS Latitude/Longitude	
				Start	End
Item	Animal Control			37.818753 °	37.818753 °
				-121.380249 °	-121.380249 °
DWR ID	DWR_RD0001_01_s_2016_10				
Comment Code					
A3 : No rodents visible, but rodent burrows visible; need to backfill and compact or grout burrows.					
Inspector Comment					
Backfill and compact levee slope with acceptable levee fill.

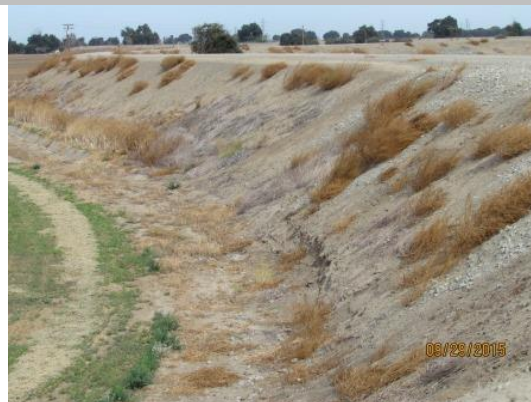
Photo 1 of 1 : SP_2017_RD0001_23_5_20170407_00006.jpg

View of the vertical cut at the landside levee toe.

LM Start	0.51	Rating **	M	Issue No.	5
LM End	0.51	Issue Type +	Ma	Location *	LS
Category	Earthen Levee			GPS Latitude/Longitude	
				Start	End
Item	Slope Stability			37.818003 °	37.818003 °
				-121.379845 °	-121.379845 °
DWR ID	DWR_RD0001_01_f_2015_5				
Comment Code					
S1 : Repair slope instability.					
Inspector Comment					
About a 1 ft. vertical cut is observed at the landside levee toe. Repair the landside levee toe per O&M standards.

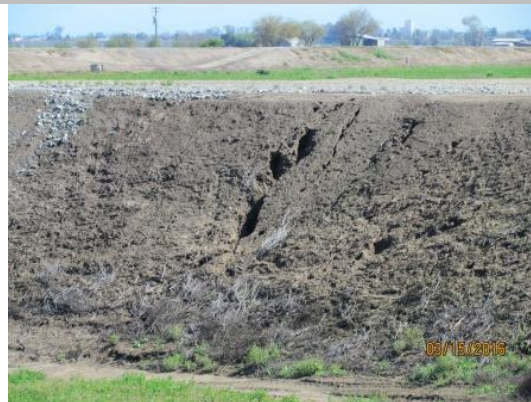
Photo 1 of 1 : SP_2017_RD0001_23_7_20170407_00007.jpg

View of the erosion on the landside levee slope.

LM Start	0.52	Rating **	M	Issue No.	7
LM End	0.52	Issue Type +	Ma	Location *	LS
Category	Earthen Levee			GPS Latitude/Longitude	
				Start	End
Item	Erosion / Bank Caving			37.817825 °	37.817825 °
				-121.379811 °	-121.379811 °
DWR ID	DWR_RD0001_01_s_2016_7				
Comment Code					
E2 : Schedule repair of erosion site prior to the next inspection.					
Inspector Comment

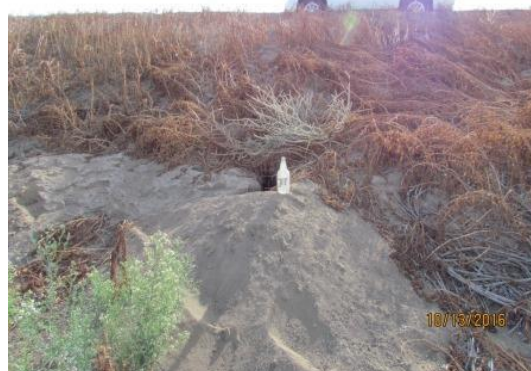
Photo 1 of 1 : SP_2017_RD0001_23_15_20170407_00012.jpg

View of the large rodent burrow in the landside levee slope.

LM Start	0.67	Rating **	U	Issue No.	15
LM End	0.67	Issue Type +	Ma	Location *	LS
Category	Earthen Levee			GPS Latitude/Longitude	
				Start	End
Item	Animal Control			37.817047 °	37.817047 °
				-121.382342 °	-121.382342 °
DWR ID	DWR_RD0001_01_f_2016_15				
Comment Code					
A1 : Exterminate rodents and backfill and compact or grout burrows.					
Inspector Comment					
Burrow entrance is about 18 inches by 10 inches.

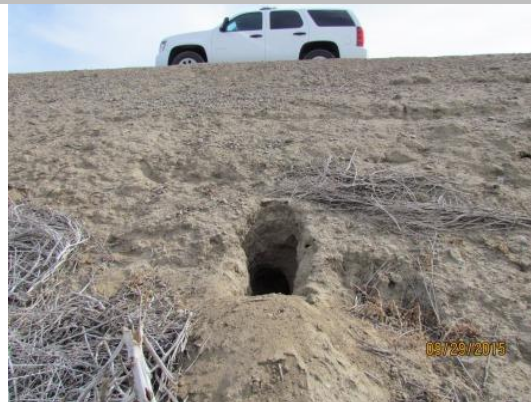
Photo 1 of 1 : SP_2017_RD0001_23_4_20170407_00005.jpg

View of a large rodent hole on the landside levee slope.

LM Start	0.76	Rating **	U	Issue No.	4
LM End	0.76	Issue Type +	Ma	Location *	LS
Category	Earthen Levee			GPS Latitude/Longitude	
				Start	End
Item	Animal Control			37.815881 °	37.815881 °
				-121.382704 °	-121.382704 °
DWR ID	DWR_RD0001_01_f_2015_4				
Comment Code					
A1 : Exterminate rodents and backfill and compact or grout burrows.					
Inspector Comment					
Large burrow in the landside levee slope. Possible fox den. Cobwebs are visible in the hole. Fall 2016.

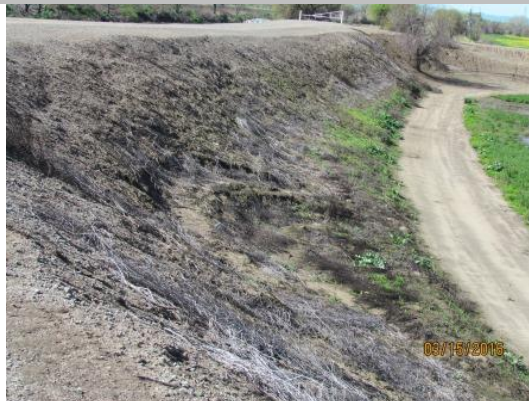
Photo 1 of 1 : SP_2017_RD0001_23_3_20170407_00004.jpg

View of the landside slope damaged by farm equipment.

LM Start	1.08	Rating **	M	Issue No.	3
LM End	1.08	Issue Type +	Ma	Location *	LS
Category	Earthen Levee			GPS Latitude/Longitude	
				Start	End
Item	Slope Stability			37.812023 °	37.812023 °
				-121.383961 °	-121.383961 °
DWR ID	DWR_RD0001_01_s_2016_3				
Comment Code					
S3 : Repair the levee slope damaged by vehicle traffic and prevent access where possible.					
Inspector Comment					
Repair slope damaged by vehicle by placing and compacting acceptable levee material.
